# **Limited Exterior Masonry Assessment Jackson Elementary School**

Volume 1 of 2

Updated April 15, 2008  
November 29, 2007

Produced for:  
Medford Public Schools  
Medford, Oregon

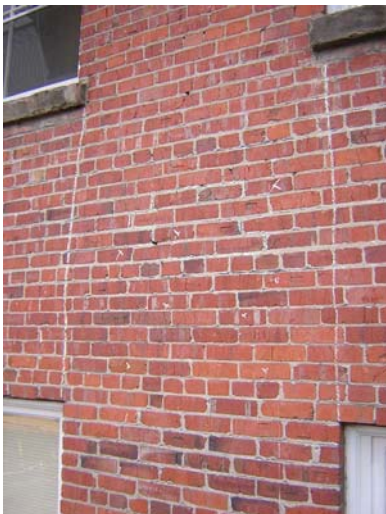
A significant visual difference is evident in comparing the material quality and labor workmanship between the rust colored brick and the blond brick. The blond brick has a very smooth surface void of imperfections and irregularities and was installed with ¼” or less masonry joints. The rust colored brick, however, exhibits numerous surface cracking, spalling of edges due to the cracking, and an irregular surface with many “imperfections.” One such imperfection is a 2” long horizontal indentation likely made from a tool used to remove the masonry units during the firing process. Mortar joints are struck flush with the brick face and are 3/8” to ½” wide. Header courses occur every 8<sup>th</sup> course vertically and the field bricks were laid in a running

bond. The irregularities, cracking, and workmanship were observed on all three facades of Jackson Elementary School with consistent and similar amounts.

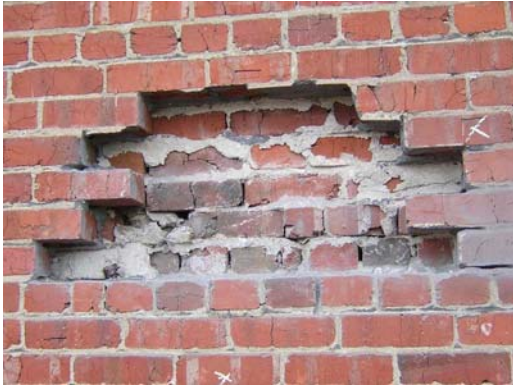
After consultation on site with ABHT Structural Engineers and Rogue Valley Masonry, Peter Meijer Architect, LLC selected two locations at the level of the second floor framing on the east and west elevations as being representative of existing conditions. An area approximately 10ft x 10ft square was marked and each individual brick unit was observed for cracking. Approximately 100 brick units, not counting the header courses, were contained within the boundaries of the area. Of these 100 brick, only seven (7) units were noted to be either without cracks or very minor cracks.

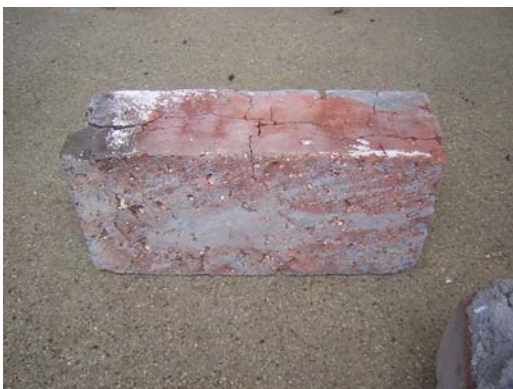
After noting the condition of the face bricks, approximately 15 units were removed from the wall in an area roughly 3 running units wide by five courses high. The lower boundary of the opening was made just above the header course in order to verify the bonding and construction techniques. The initial removal process used a masonry saw to cut the horizontal joints followed by hand tools to scrape out the remaining mortar. After the initial brick units were removed, the removal process was

slightly modified to eliminate the use of power tools and utilize only hand tools to remove the mortar.

The masonry courses are set in full bed joints, full back side joints, and head joints all of which meet industry standard construction practices. Although the mortar is “soft,” the existing mortar joints are not exhibiting signs of failure. PMA conducted a limited observation of interior walls but did not observe signs of water intrusion. Mortar within the joints had not failed due to water intrusion or other sources. PMA did not conduct petrographic analysis on the existing mortar, but physical observation combined with knowledge of historic mortars suggests that the existing mortar is lime based. The bed and head mortar of the face veneer has been colored a dark grey. The mortar used for setting the back-up wythes and bonding the face wythe to the back up wythes is an off-white color.

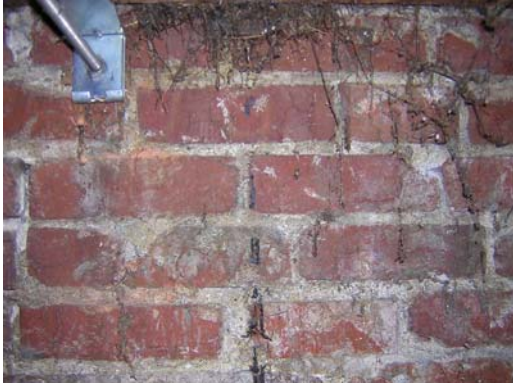
When the mortar was removed, the brick units were dismantled using hand tools. Each unit was removed intact and no units crumbled or broke with hand pressure. It was observed that the cracks on the exterior face did not propagate the full depth of the unit but were present on all six faces. The bedding surfaces of the units contain several inclusions of large sand and rock fragments and has an overall rough texture. The prevalent cracking appears to result from the clay composition and

shrinkage during drying as a result of the manufacturing process. When the cracking is clustered at the edges and corners, a portion of the unit is more likely to spall resulting in deformation of the face. The cracking and material composition was consistent from unit to unit and consistent at both elevations.

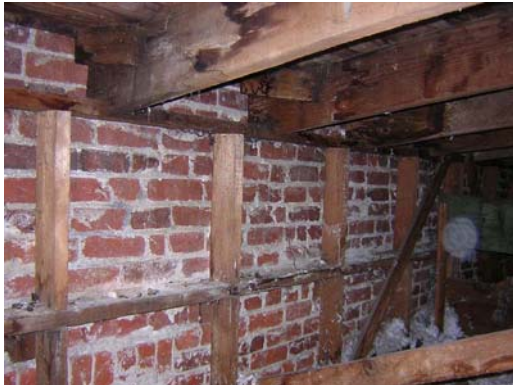
The back-up wythes (middle and interior) were observed from the exterior and attic levels respectively and found to be similar in color, composition, and texture. The number, type, and distribution of cracks in the back-up wythes was similar to the face veneer. At the attic level, previous seismic reinforcement of the roof joists consisted of connecting a steel strap to the inner masonry wythe with epoxy anchored bolts. No additional fracturing or cracking of the masonry wythes was observed at these locations.

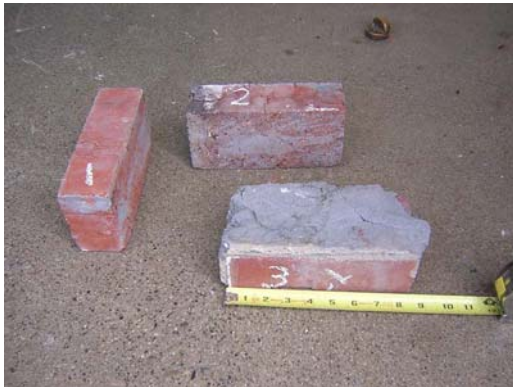
Although the construction methodologies used to build the masonry bearing wall at Jackson Elementary School are reflective of standards of the period, it is atypical for an exterior masonry veneer to be comprised of low aesthetic quality bricks. Most public buildings incorporated masonry with high quality clays and control of the manufacturing process that limited drying cracks resulting in higher aesthetic appearances. It is not unusual for back-up masonry to be composed of lower

quality units.

The cracking in the units appear to be the result of manufacturing process and not accelerated aging or water penetration. Based on our review of the brick samples taken in the field, it appears that the cracking present in the bricks may have resulted from rapid cooling after the firing process was completed. Excessively rapid cooling can result in cracking and checking of the clay brick units. Although unsightly, the cracks are not expected to increase in size over time as a result of the firing process. When removed, none of the individual brick units failed.

Due to the amount of surface cracking, some edges and faces of the existing units are spalling and will continue to spall in the future. The water absorption test results are noted above. These results were within acceptable limits for water absorption based on durability classification but slightly out of acceptable range for saturation coefficient. The susceptibility of the brick units to freeze thaw is being evaluated through controlled laboratory tests. The results of the freeze thaw testing will add to the information regarding water absorption characteristics and be incorporated into this report when available.
