Limited Exterior Masonry Assessment Roosevelt Elementary School

Volume 2 of 2

Updated April 15, 2008
November 29, 2007

Produced for:
Medford Public Schools
Medford, Oregon

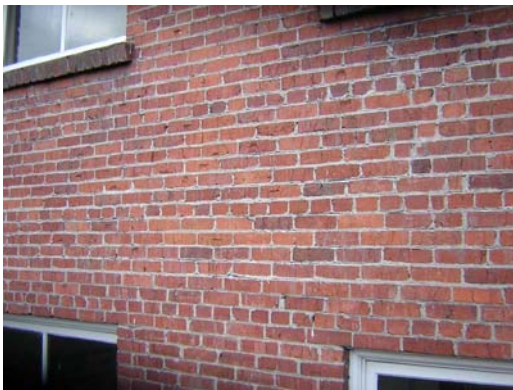
A significant visual difference is evident in comparing the material quality and labor workmanship between the rust colored brick and the blond brick. The blond brick has a very smooth surface void of imperfections and irregularities and was installed with ¼” or less masonry joints. The rust colored brick, however, exhibits numerous surface cracking, spalling of edges due to the cracking, and an irregular surface with many “imperfections.” One such imperfection is a 2” long horizontal

indentation likely made from a tool used to remove the masonry units during the firing process. Mortar joints are struck flush with the brick face and are 3/8” to ½” wide. Header courses occur every 8th course vertically and the field bricks were laid in a running bond. The irregularities, cracking, and workmanship were observed on all three facades of Roosevelt Elementary School with consistent and similar amounts.

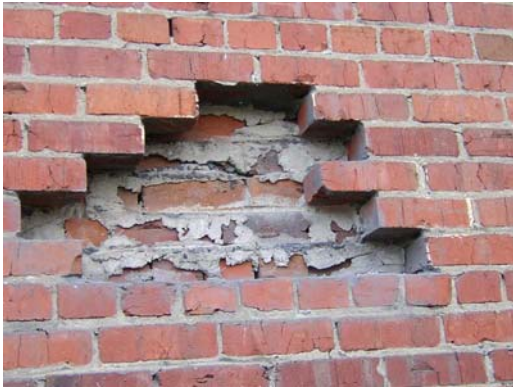
After consultation on site with ABHT Structural Engineers and Rogue Valley Masonry, Peter Meijer Architect, LLC selected two locations at the level of the second floor framing on the east and west elevations as being representative of existing conditions. An area approximately 10ft x 10ft square was marked and each individual brick unit was observed for cracking. Approximately 100 brick units, not counting the header courses, were contained within the boundaries of the

area. Of these 100 brick, only seven (7) units were noted to be either without cracks or very minor cracks.

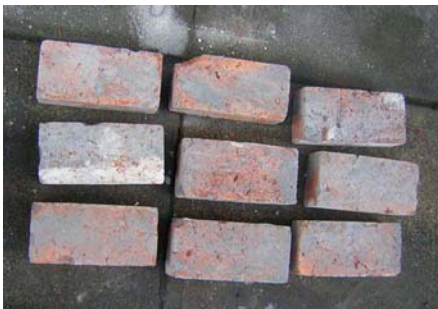
The masonry courses are set in full bed joints, full back side joints, and head joints all of which meet industry standard construction practices. Although the mortar is “soft,” the existing mortar joints are not exhibiting signs of failure. PMA conducted a limited observation of interior walls but did not observe signs of water intrusion. Mortar within the joints had not failed due to water intrusion or

other sources. PMA did not conduct petrographic analysis on the existing mortar, but physical observation combined with knowledge of historic mortars suggests that the existing mortar is lime based. The bed and head mortar of the face veneer has been colored a dark grey. The mortar used for setting the back-up wythes and bonding the face wythe to the back up wythes is an off-white color.

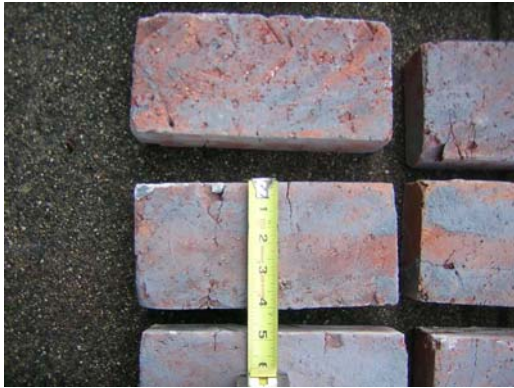
The back-up wythes (middle and interior) were observed from the exterior and attic levels respectively and found to be similar in color, composition, and texture. The number, type, and distribution of cracks in the back-up wythes was similar to the face veneer. At the attic level, previous seismic reinforcement of the roof joists consisted of connecting a steel strap to the inner masonry wythe with epoxy anchored bolts. No additional fracturing or cracking of the masonry wythes was observed at these locations.

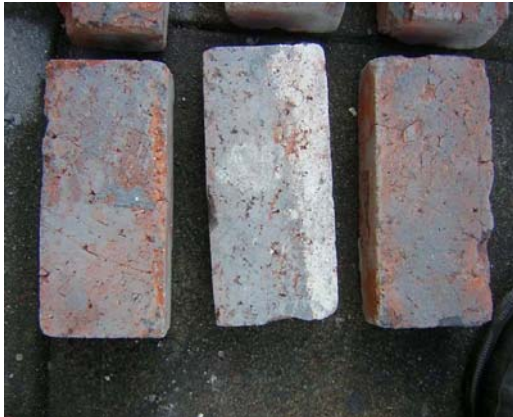
Although the construction methodologies used to build the masonry bearing wall at Roosevelt Elementary School are reflective of standards of the period, it is atypical for an exterior masonry veneer to be comprised of low aesthetic quality bricks. Most public buildings incorporated masonry with high quality clays and control of the manufacturing process that limited drying cracks resulting in higher aesthetic appearances. It is not unusual for back-up masonry to be composed of lower quality units.

The cracking in the units appear to be the result of manufacturing process and not accelerated aging or water penetration. Based on our review of the brick samples taken in the field, it appears that the cracking present in the bricks may have resulted from rapid cooling after the firing process was completed. Excessively rapid cooling can result in cracking and checking of the clay brick units. Although unsightly, the cracks are not expected to increase in size over time. When removed, none of the individual brick units failed.

Due to the amount of surface cracking, some edges and faces of the existing units are spalling and will continue to spall in the future. The water absorption test results are noted above. These results were within acceptable limits for water absorption based on durability classification but slightly out of acceptable range for saturation coefficient. The susceptibility of the brick units to freeze thaw is being evaluated through controlled laboratory tests. The results of the freeze thaw testing will add to the information regarding water absorption characteristics and be incorporated into this report when available.
